Fibergrate
Composite Structures

FIBERGRATE™ STAIR TREAD COVER INSTALLATION

1/8" FIBERGLASS TREAD COVERS

ICO-GEL™ EPOXY FILLER/ADHESIVE

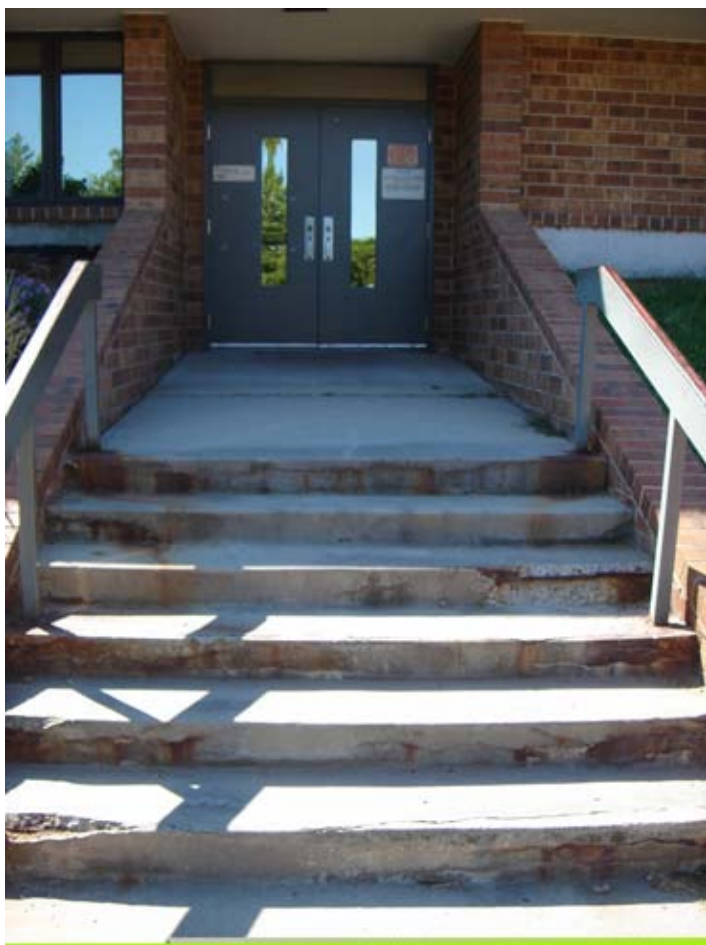
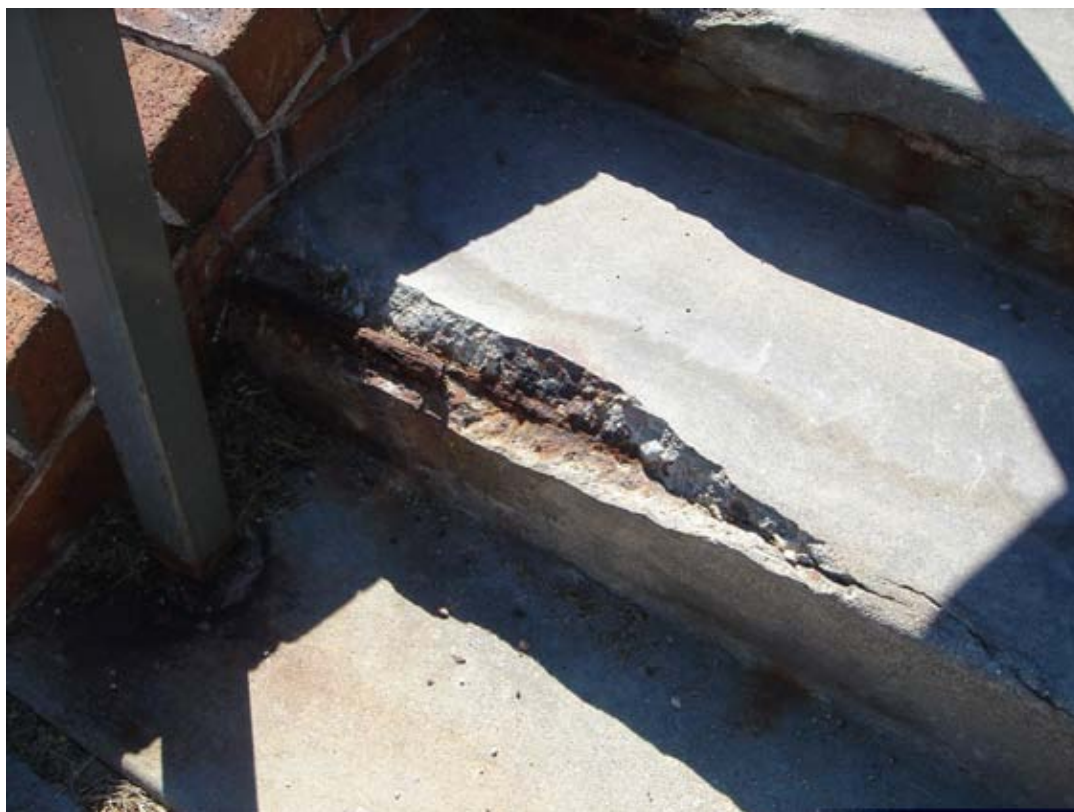
Existing Staircase

- Boulder Valley School District
- Existing entry stairs – Very Dangerous!
- Concrete spalling, re-bar exposed, rusting
- Freeze/thaw action, breaks concrete apart
- Salt exposure – rusts/expands re-bar – causing further spalling
- Replace entire staircase....OR.....

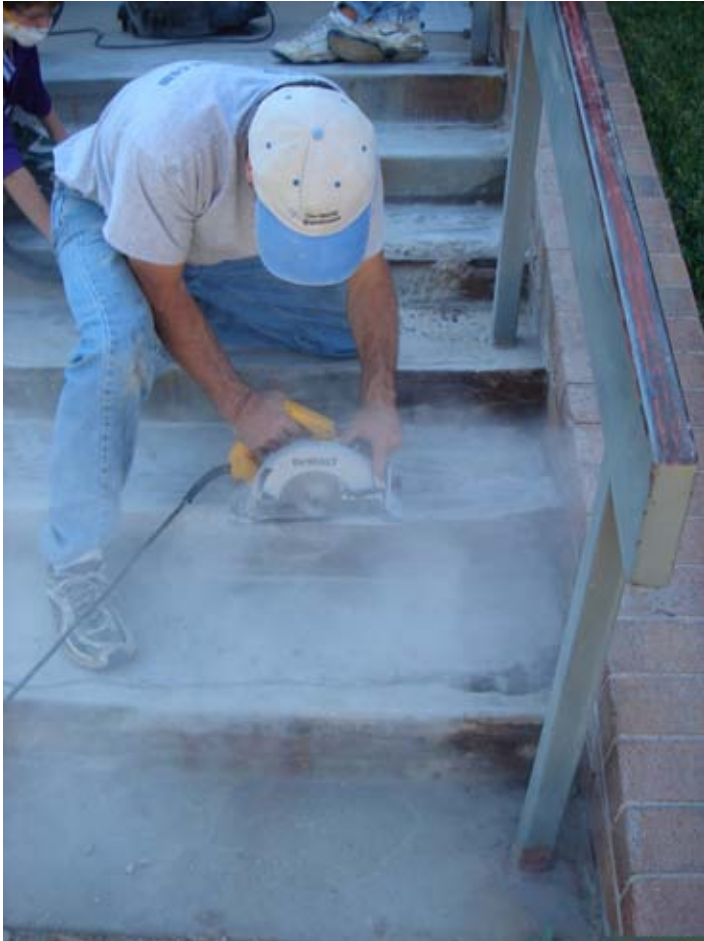
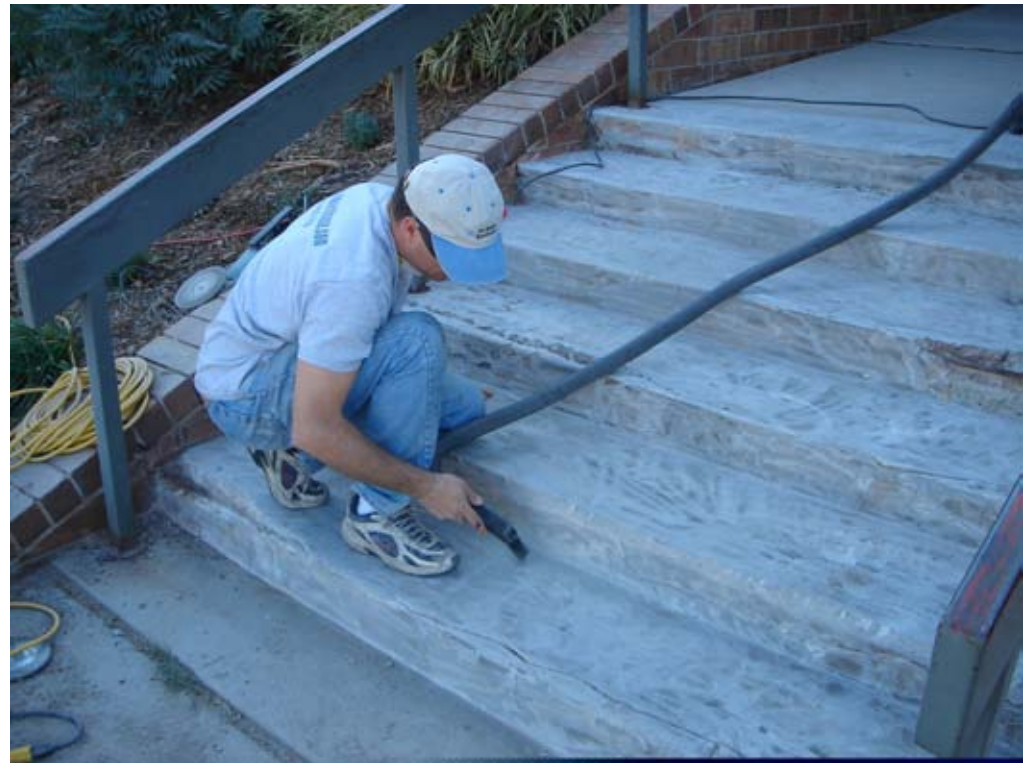
Cutting & Shaping of Bad Concrete & Surface Grinding

- All loose concrete removed
- Surface is prepared using diamond grinder
- All dust removed – washed, degreased and acid etched (if possible)
- Surface is allowed to dry or is flamed (heated)
- Primer is NOT necessary – but could be used if time allows
- ICO-GEL is applied first to fill large holes – can be blended with 3/8” clean pea gravel

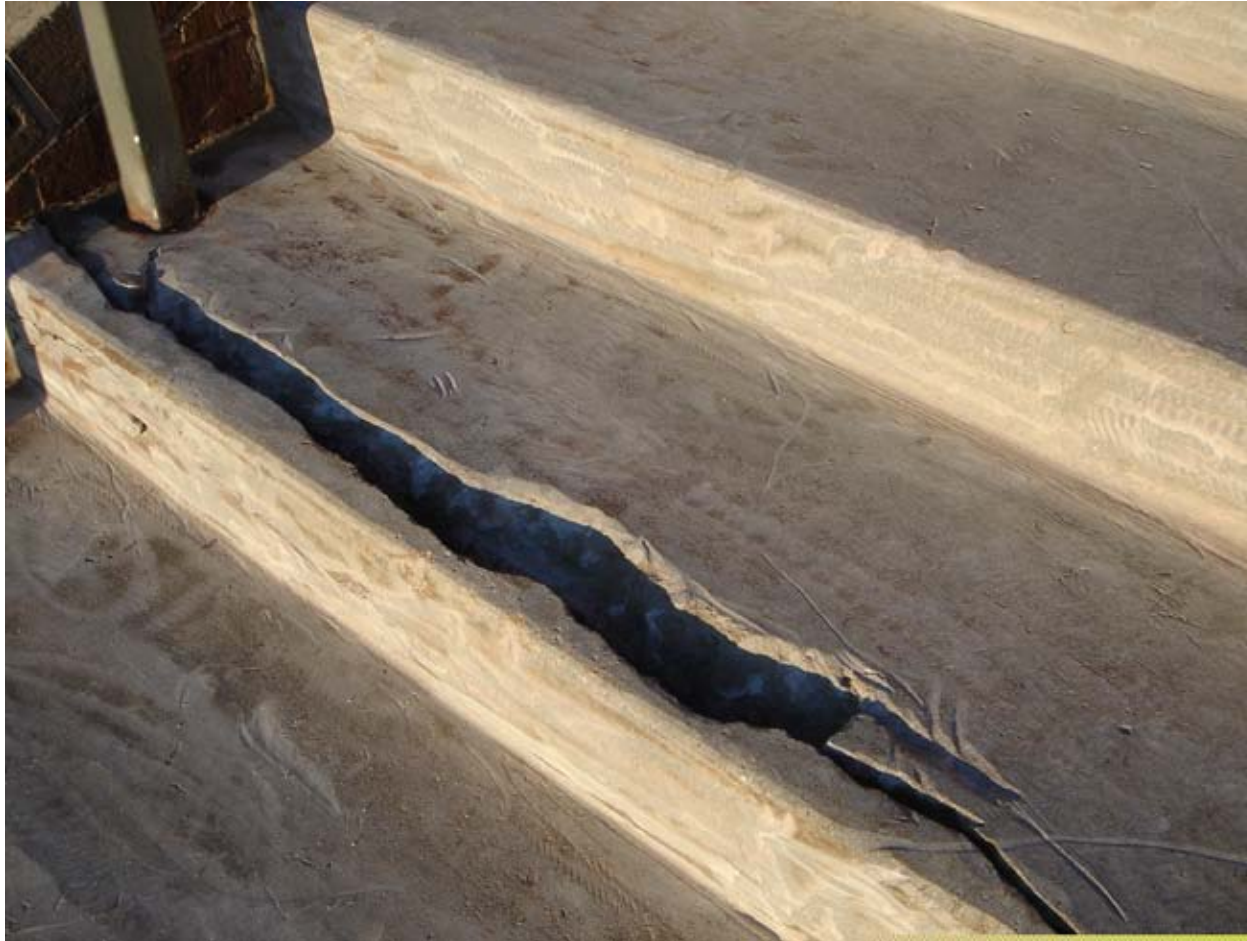
Fully Cleaned & Prepared Treads Filled with ICO-GEL™ & Pea Gravel

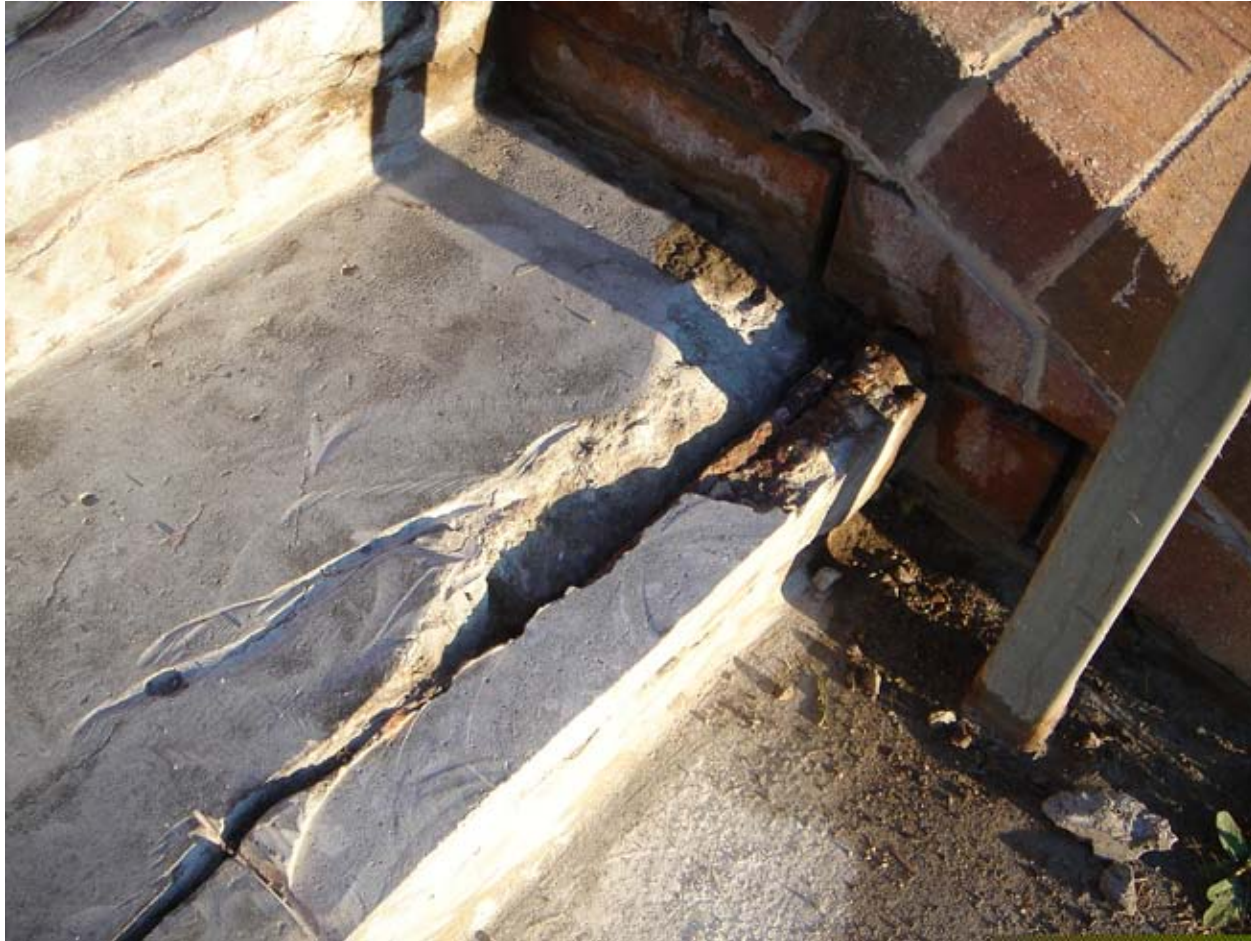
Fully Cleaned & Prepared Treads Filled with ICO-GEL™ & Pea Gravel

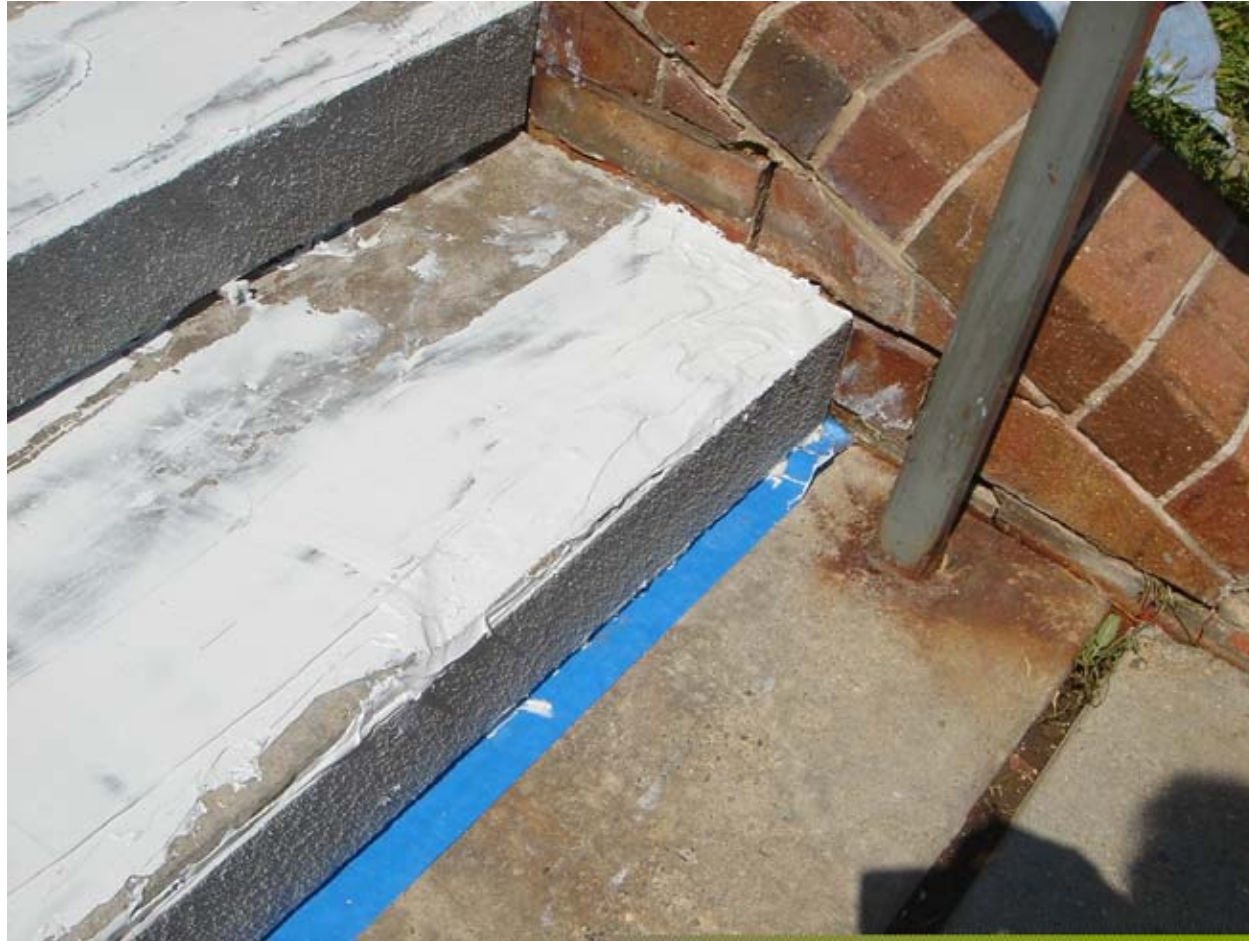
Vertical 1/8" Fiberglass Risers Cut to Size - Filled With ICO-GEL™

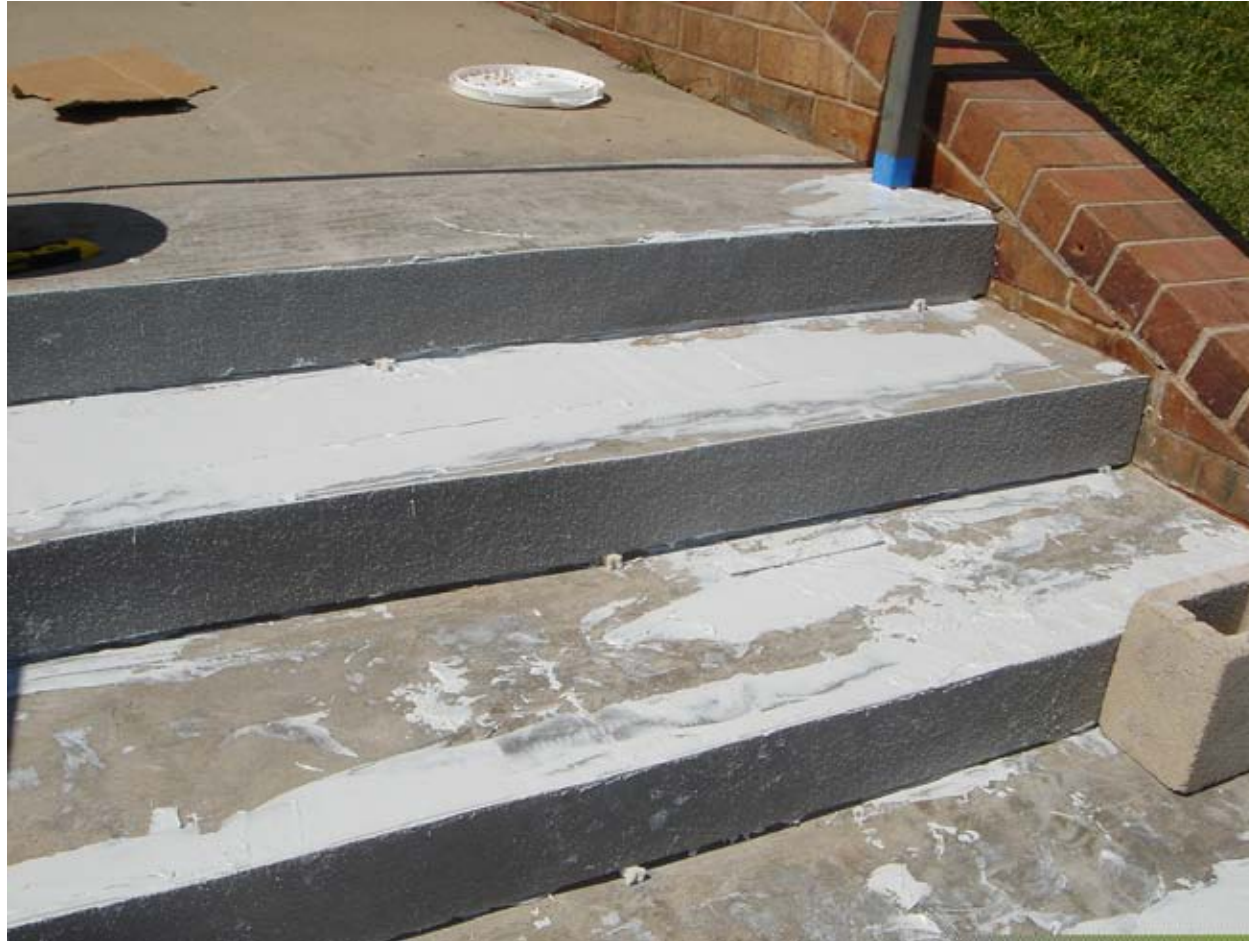
Fiberglass Risers Create a Level Tread – Ready to Accept Tread Cover

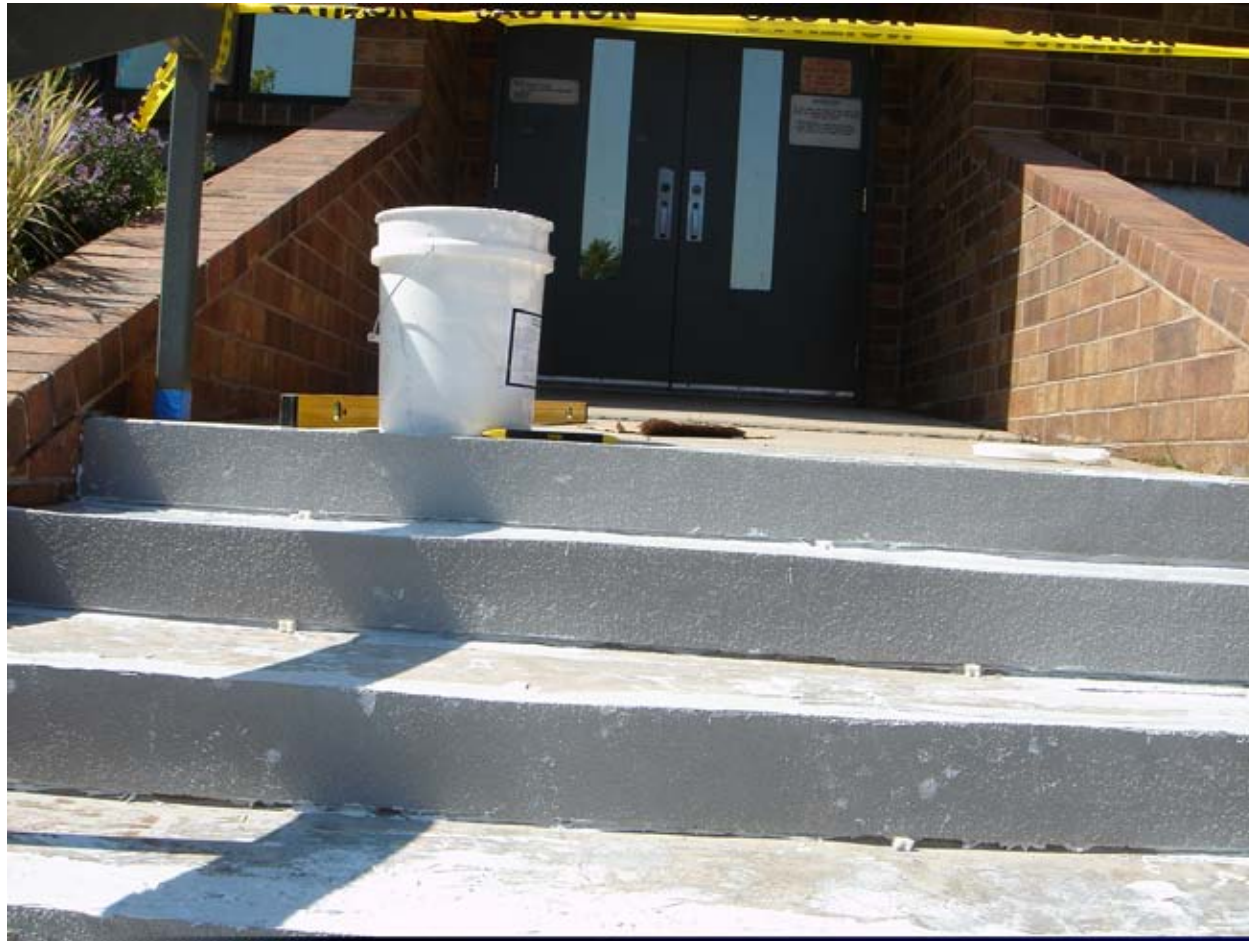
Vertical 1/8" Fiberglass Risers Leveled & Ready for Tread Covers

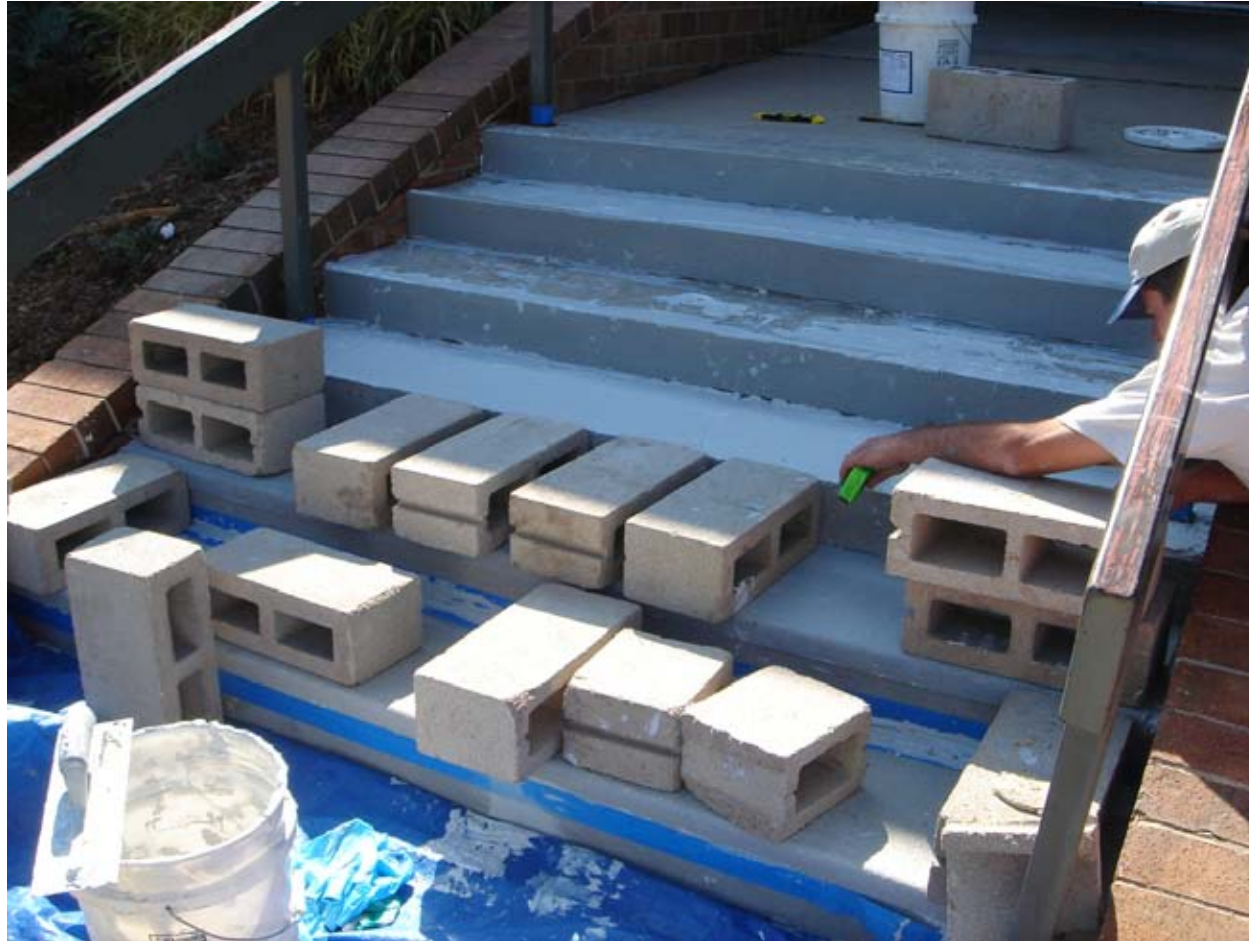
Tread Covers Applied Without Fasteners...ICO-GEL™ Adhesive

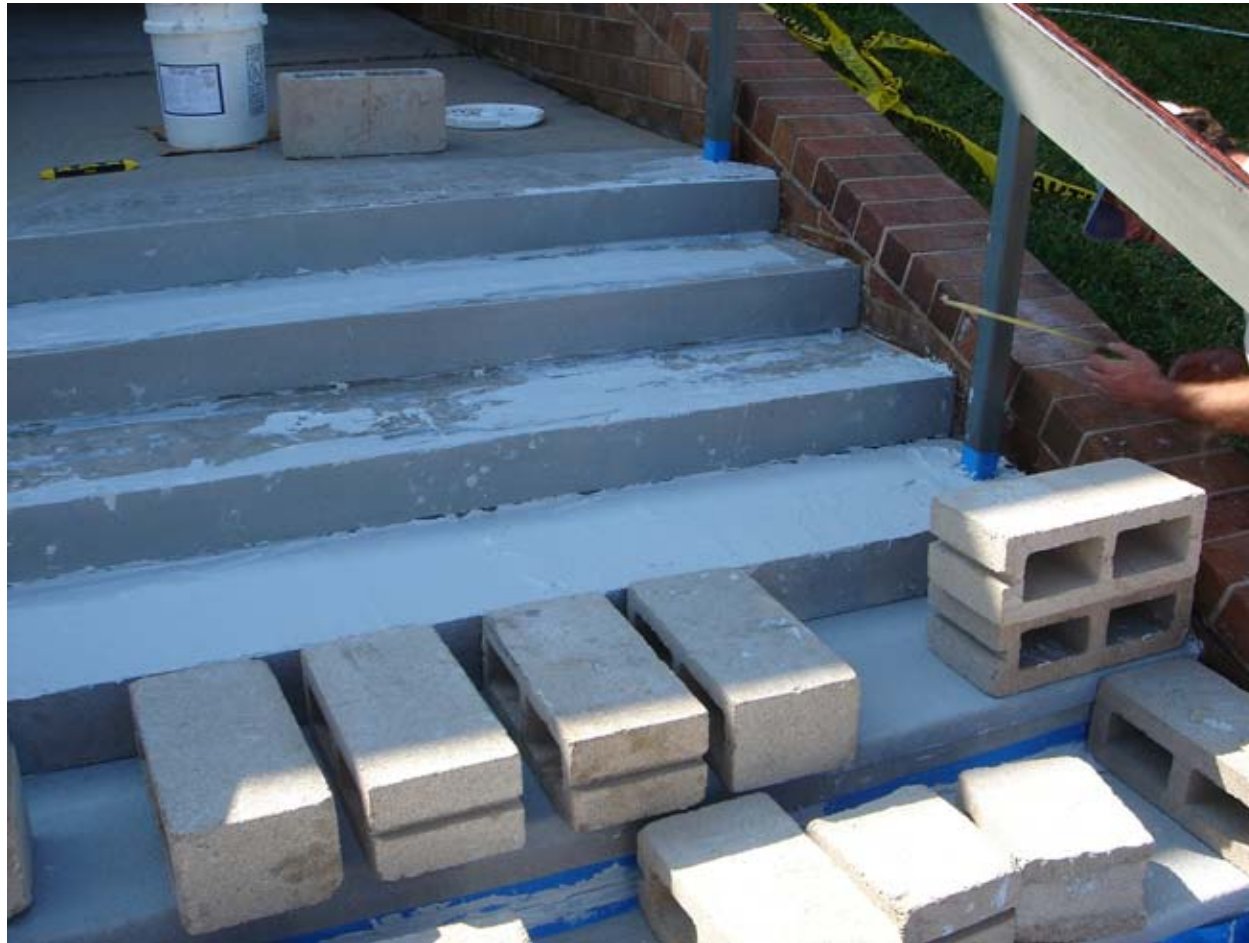
Treads Weighted – Concrete Blocks Until ICO-GEL™ Cures

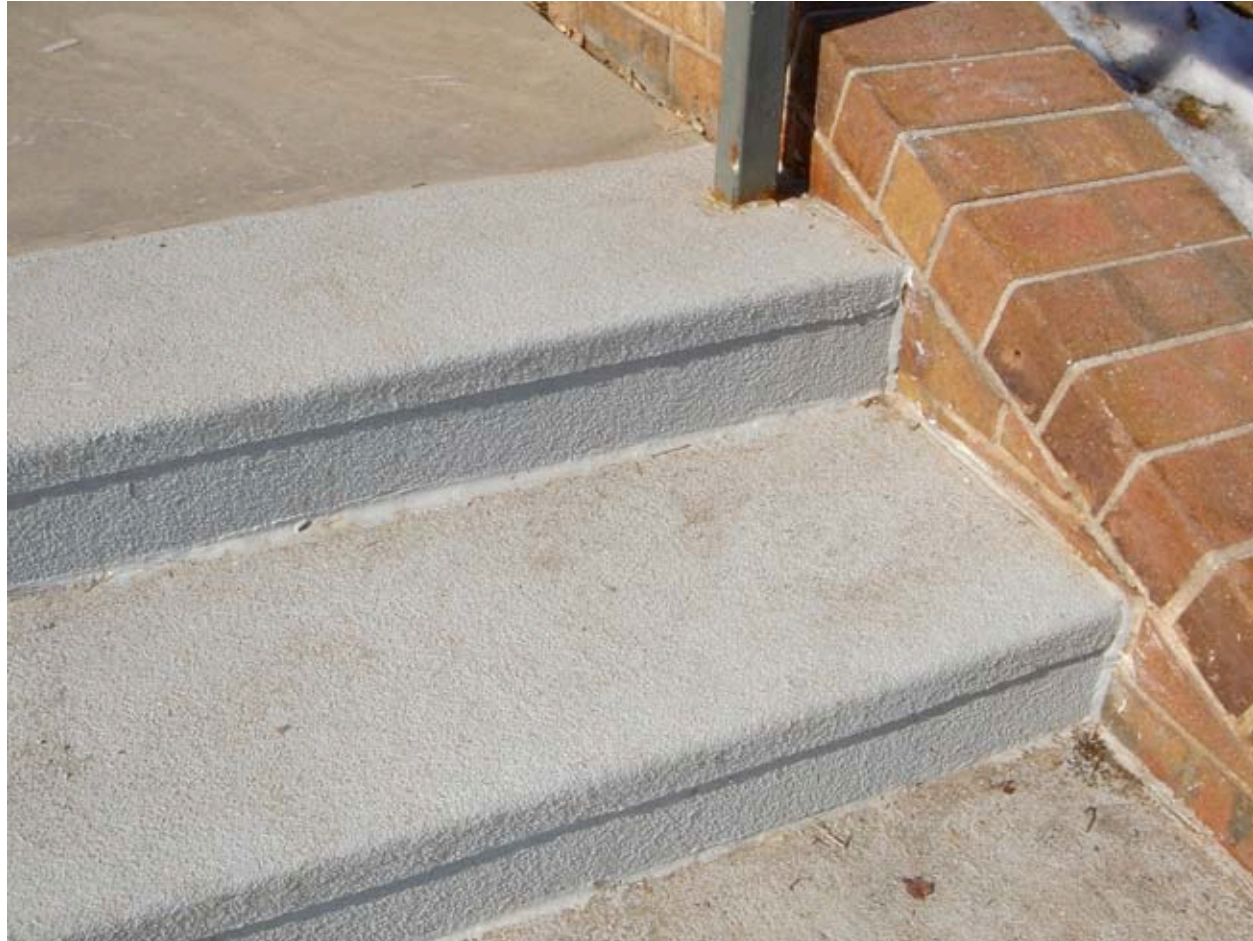
Stairs Repaired!

Safe, Non-Skid Gritted Surface

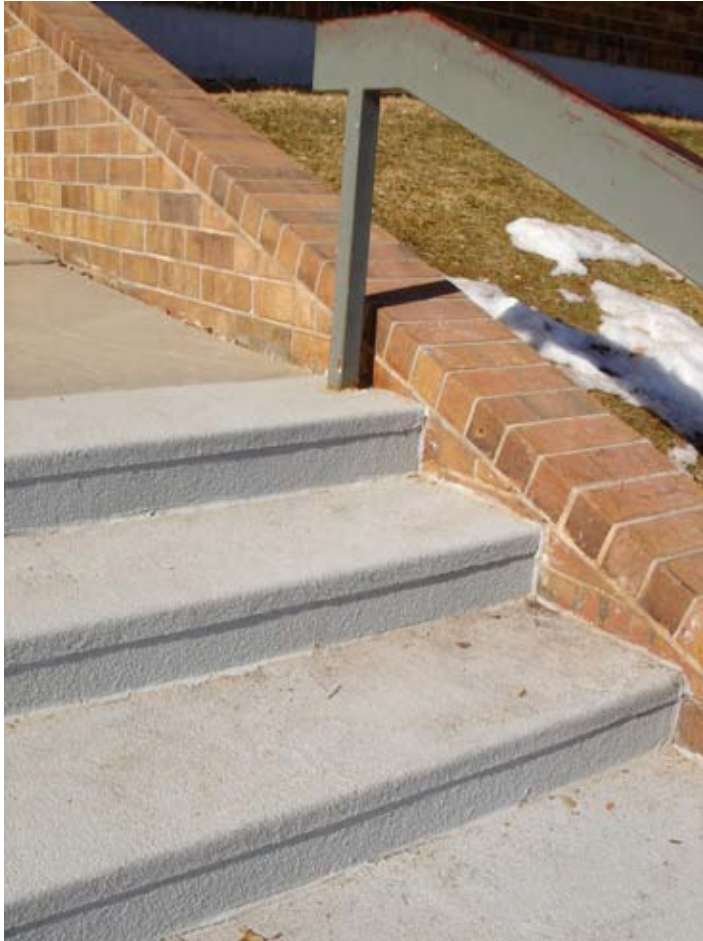
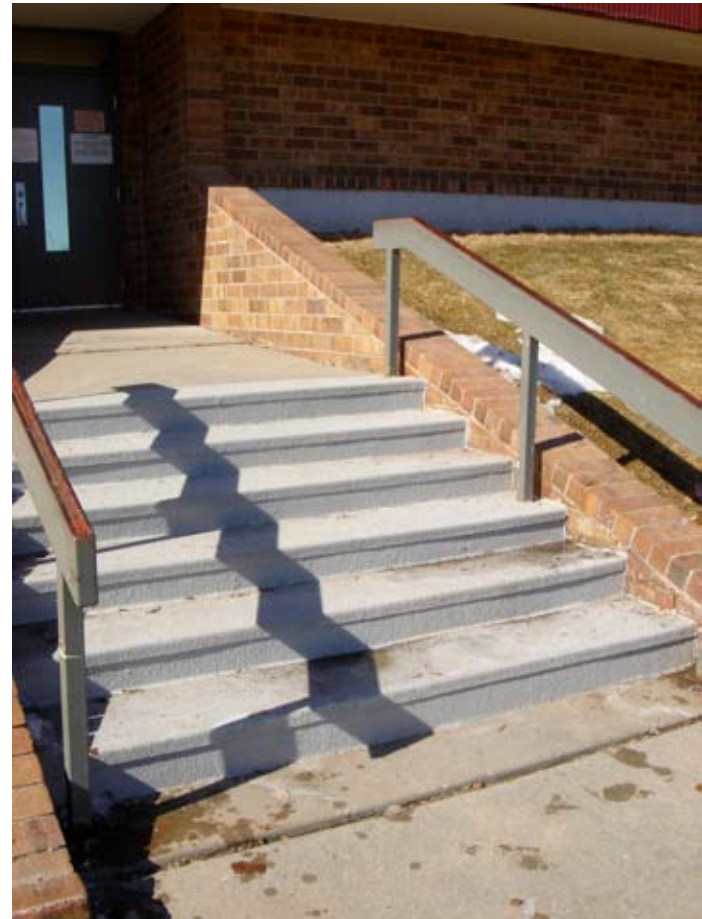
Stairs Leveled Corrected Slope for Proper Drainage

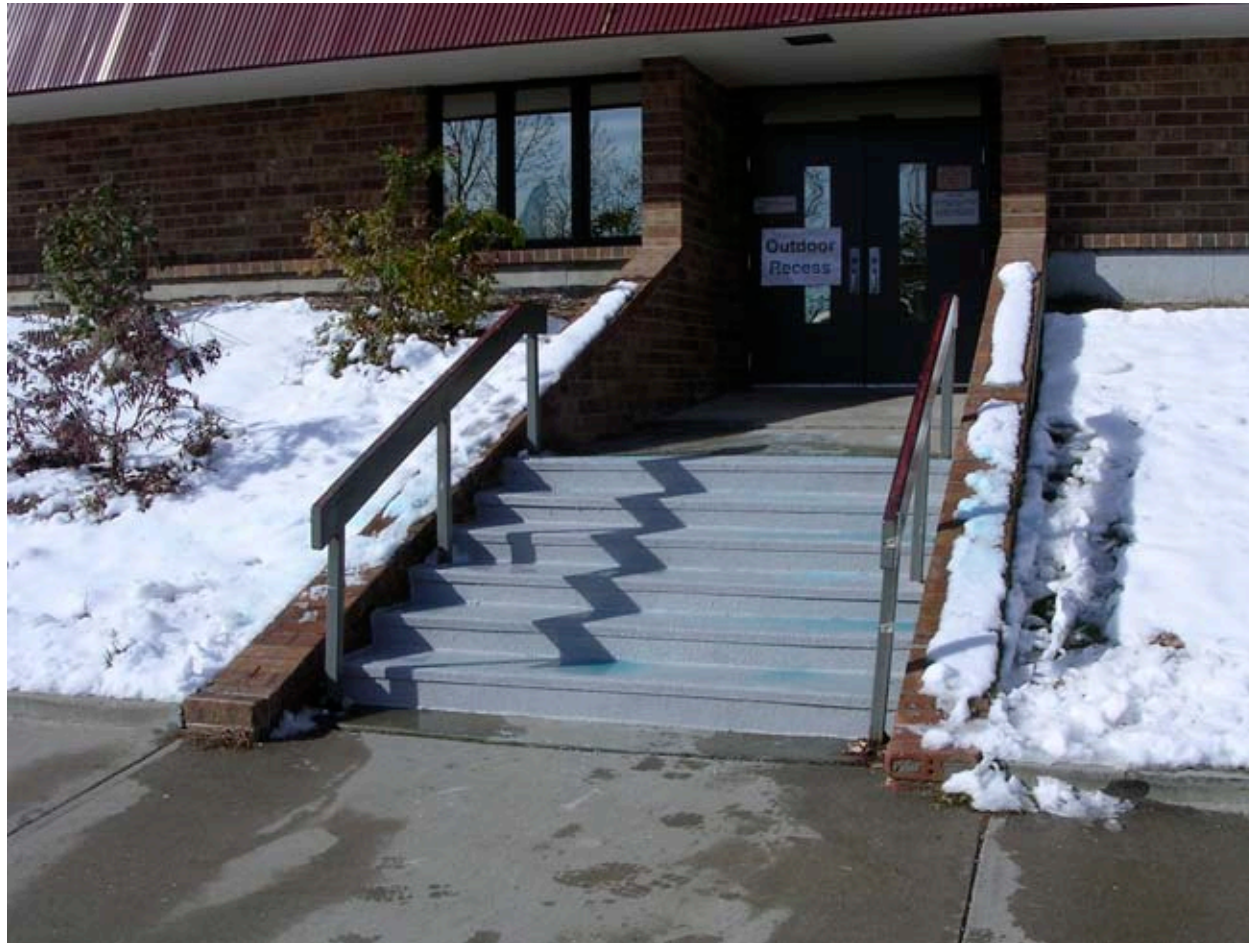
COMPLETED STAIR TREAD REPAIRS

Fibergrate™ & ICO-GEL™
