Case History – University of Colorado, Boulder, CO

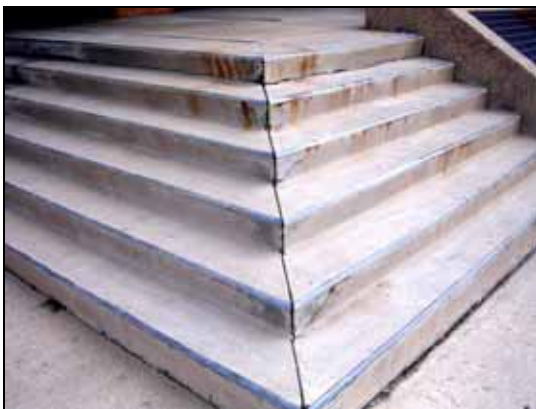
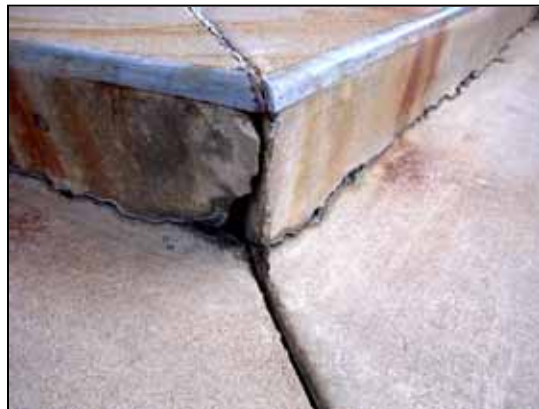
The University of Colorado in Boulder, CO had been experiencing problems with the deterioration of some of their concrete steps. The stairs had been compromised by cracks allowing water to penetrate and freeze-thaw to occur. Frost heaving is common in Colorado with daily temperature swings of 20 to 60 degrees Fahrenheit not unusual in the early winter and spring seasons. Constant use had also caused wear zones and uneven surfaces that were beginning to become a hazard.

The first step was to remove all the old failing concrete, the stairs were then cleaned and acid etched to provide a clean sound substrate for the ICO Gel to bond to.

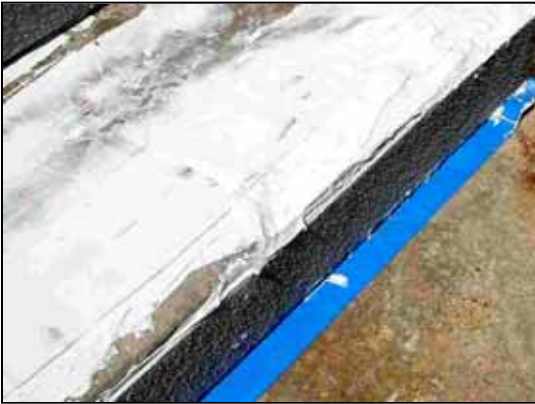
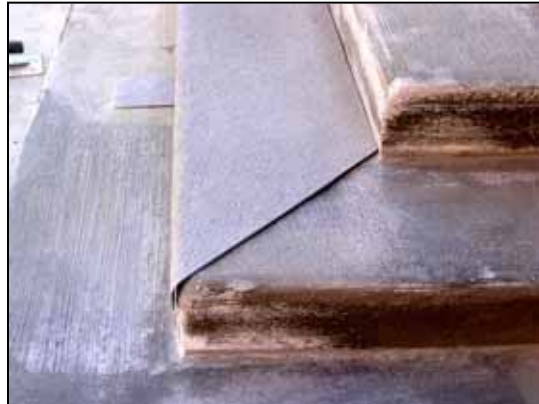
This set of steps have already been in service at the University of Colorado for three years and Accentuate Construction is currently under contract to fix hundreds more over the next four years.

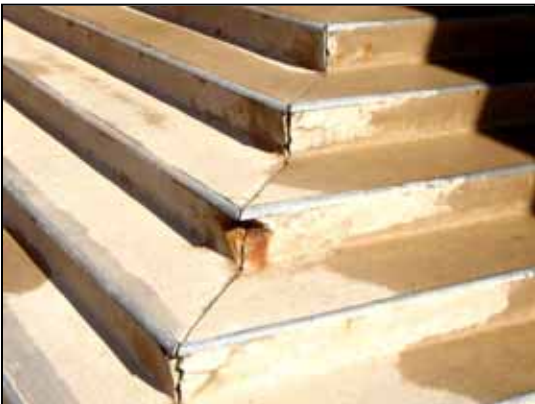
Before

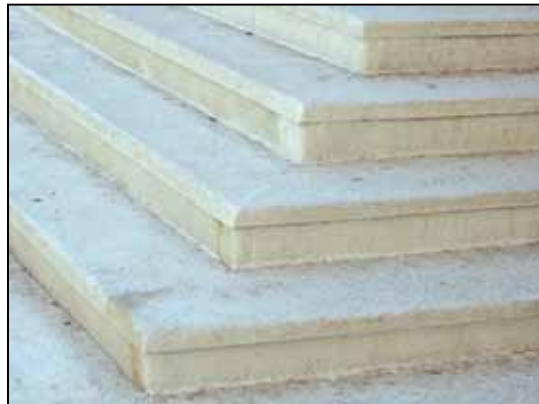
After
